David A. Andersen & Associates

Home Inspection Report

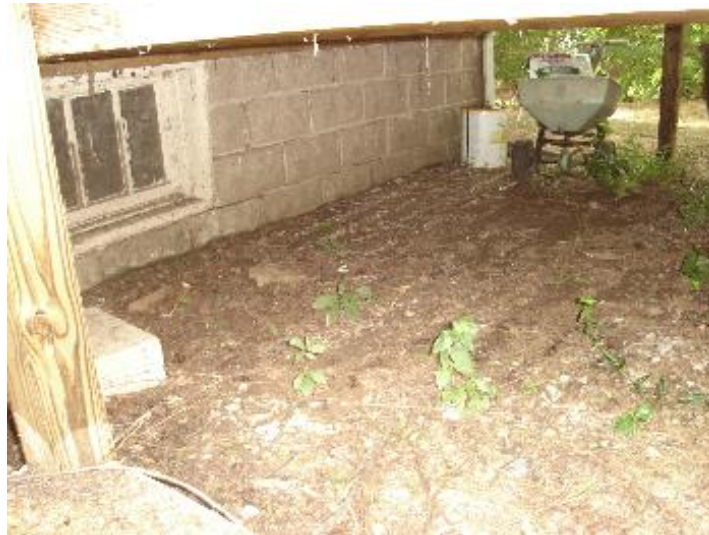
Negative grade below the deck towards the foundation. Potential source of moisture intrusion to the basement. Discharging gutter adjacent to this location.

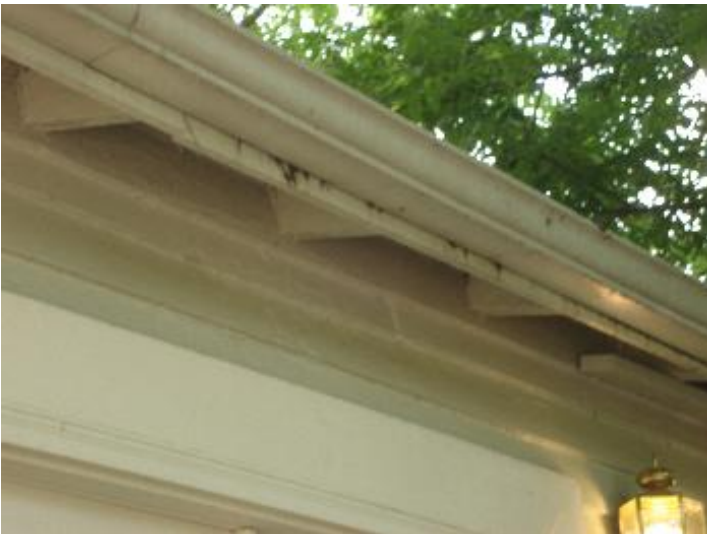
Indication of back flowing gutter; tree debris.

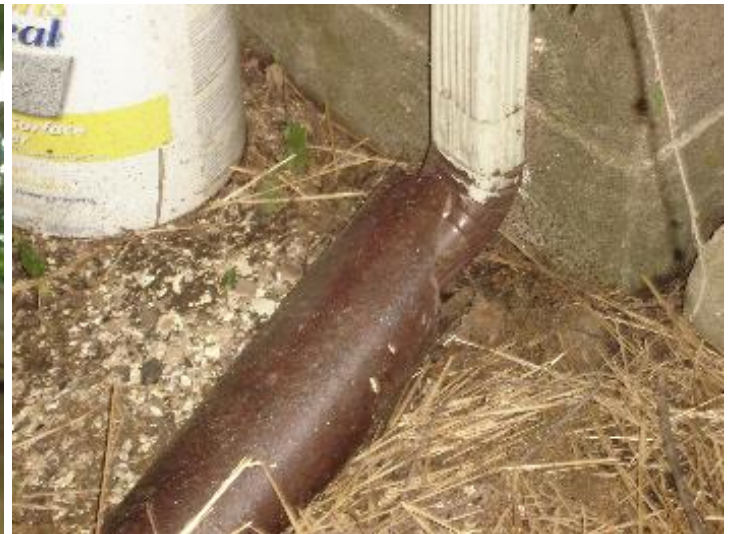
Inadequate downspout diversion potential against foundation. Monitor.

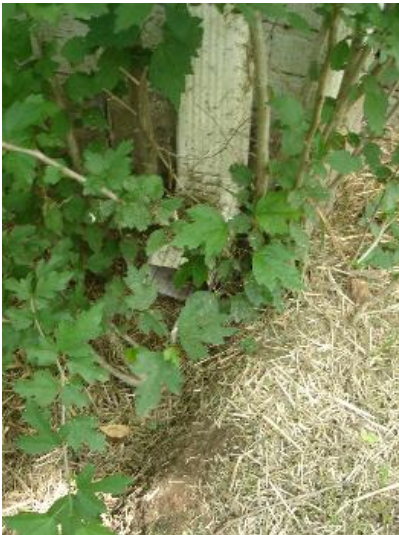
No gutter downspout diversion to remove rainwater away from the foundation.

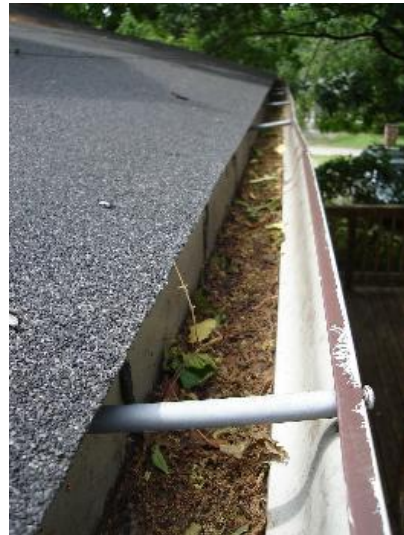
Gutters clogged with tree debris. Improper nailing of the rolled roofing.

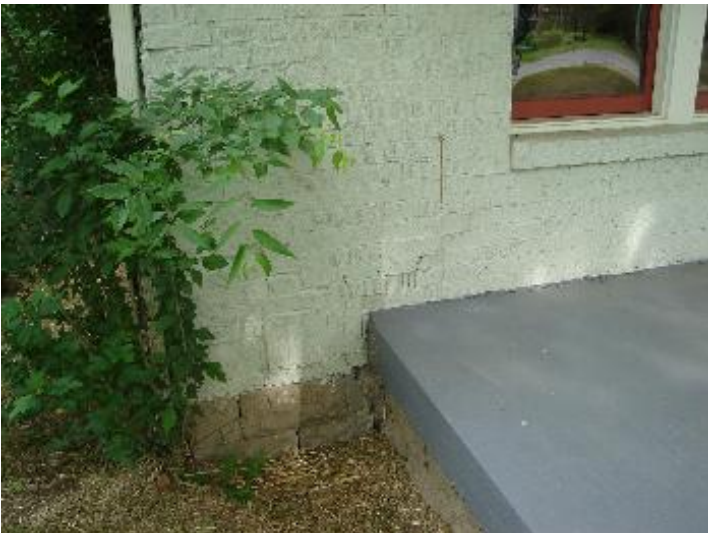
Settling crack with lateral movement. No indication of current activity.

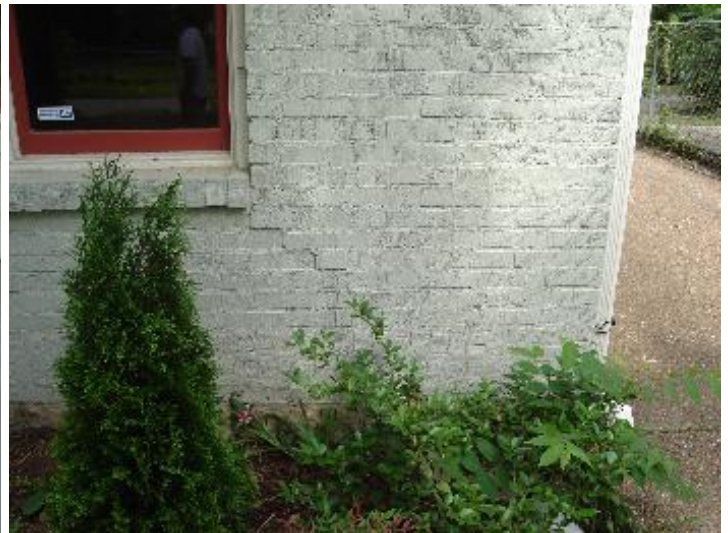
Historical reference.

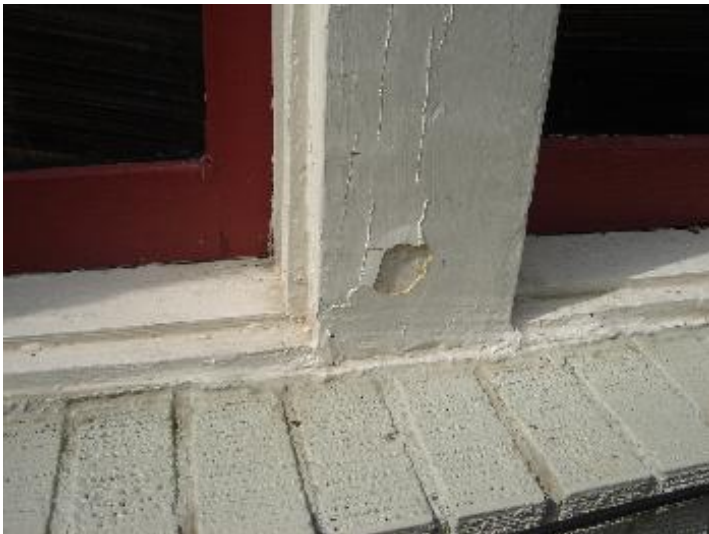
Paint maintenance required. Potential lead paint issue.

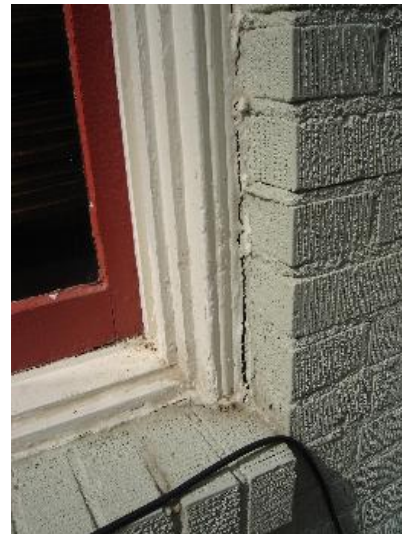
Inadequate seal between window open and wall. Potential source of moisture intrusion and window damage. A source of water to the interior wall.

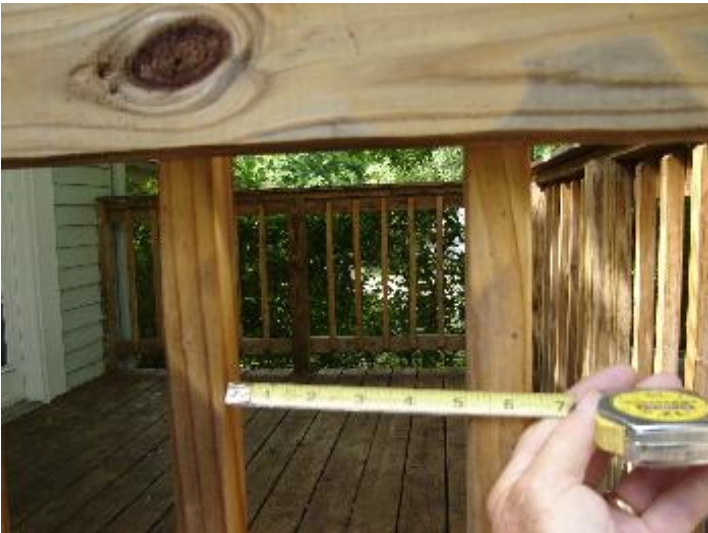
Balusters spacing exceeds 4 inch requirement.

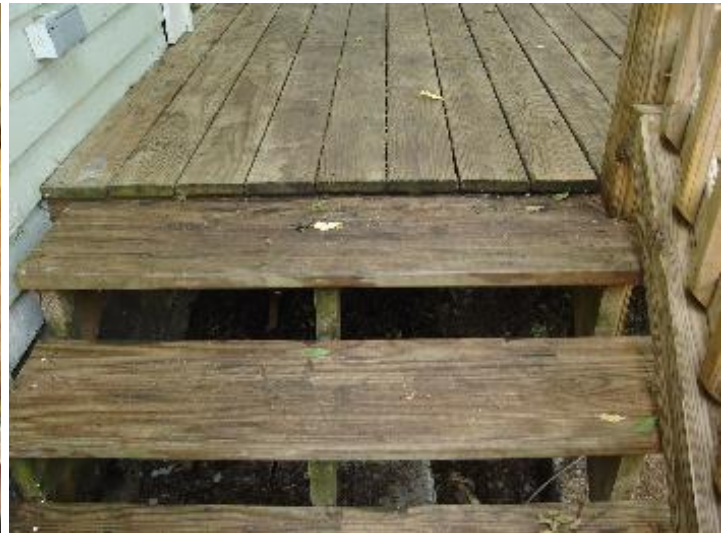
Irregular step riser; potential trip hazard.

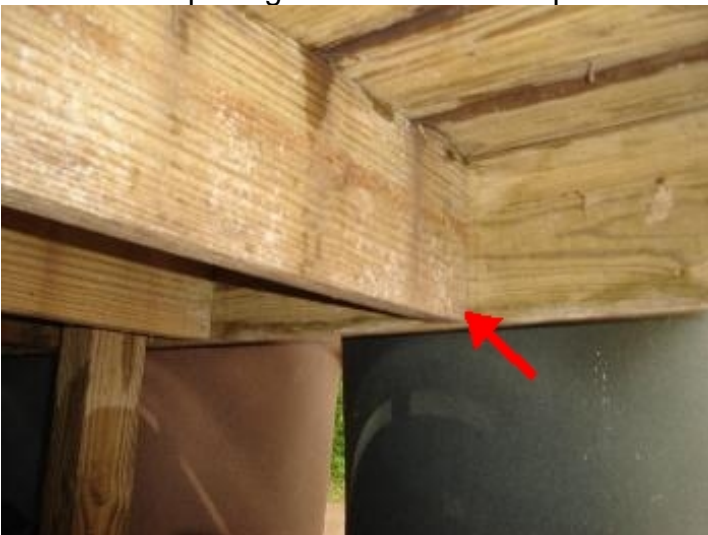
Deck joist installation inadequate. No joist hangers are installed. No ledger board installed.

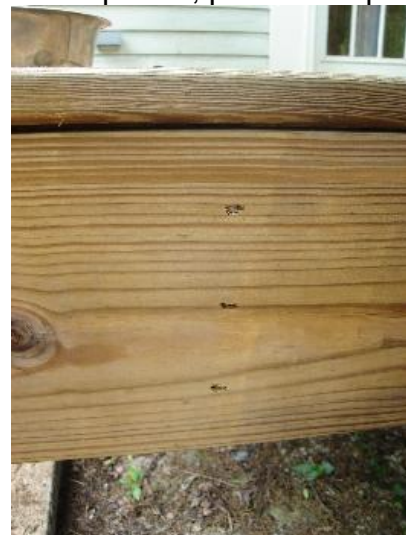
Joists are end nailed with three small pneumatic nails. Deck failure potential under load. Joist hanger installation required.

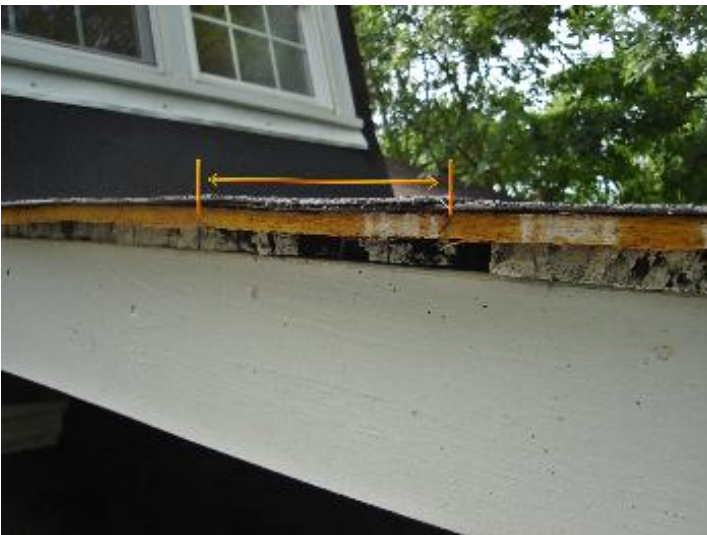
Inadequate overlap of rolled roofing material layers for a low pitched roof. No drip edge flashing installed.

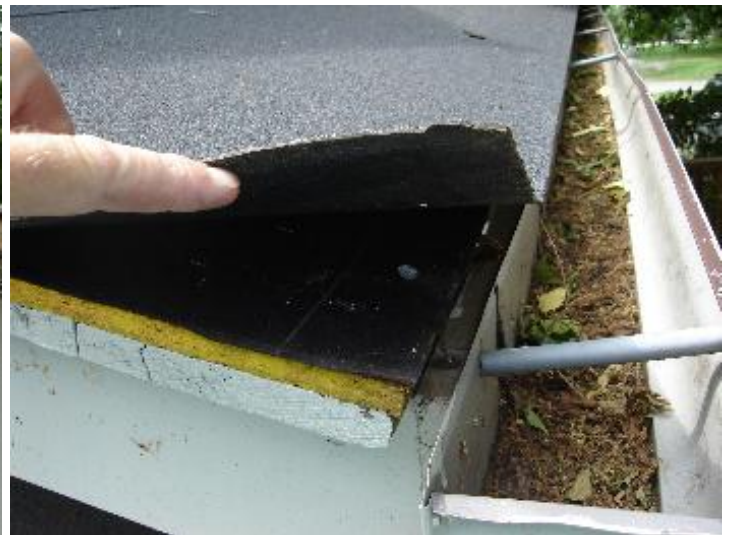
Wind damage at the leading edge of the rolled roofing. Inadequate flashing.

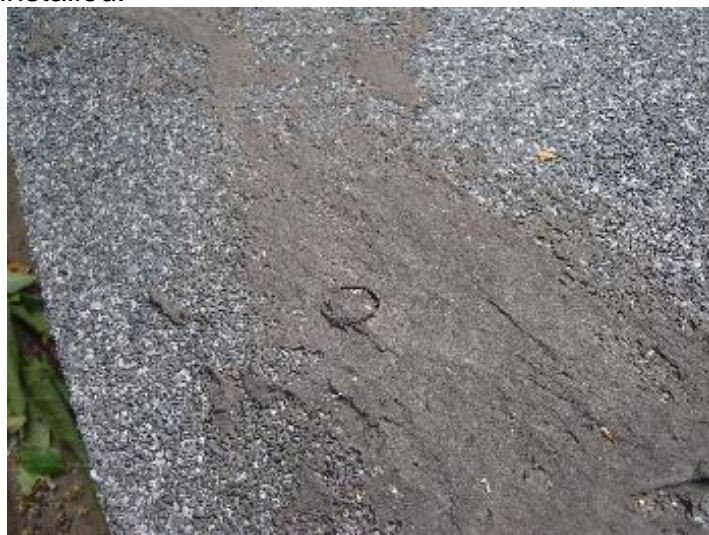
Deterioration of roofing cement at nail heads. Potential water damage to the sub-roofing.

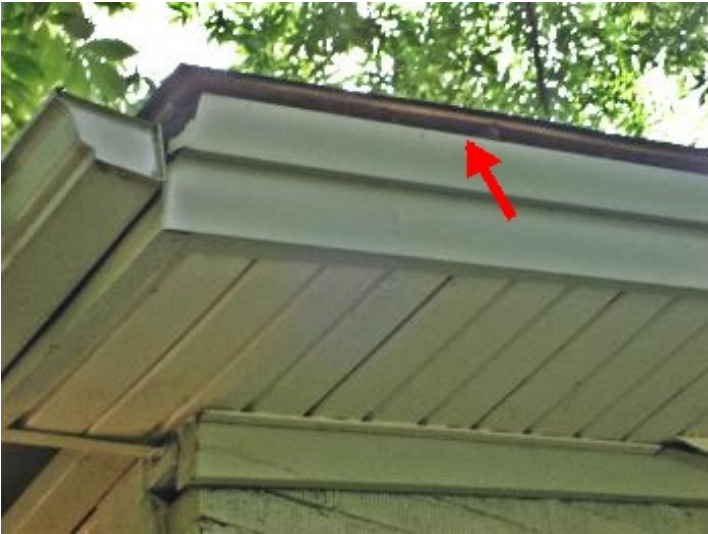
No drip edge or rake flashing installed. Exposed oriented strand board; will deteriorate from water damage.

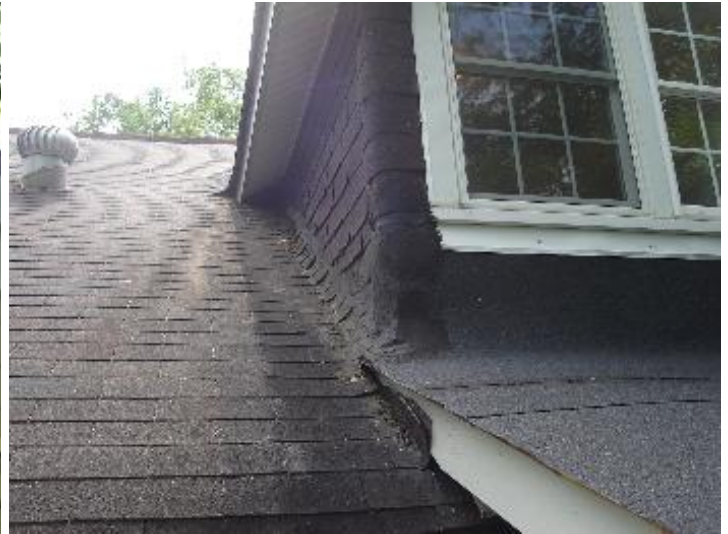
Nonstandard roof shingle to wall application.

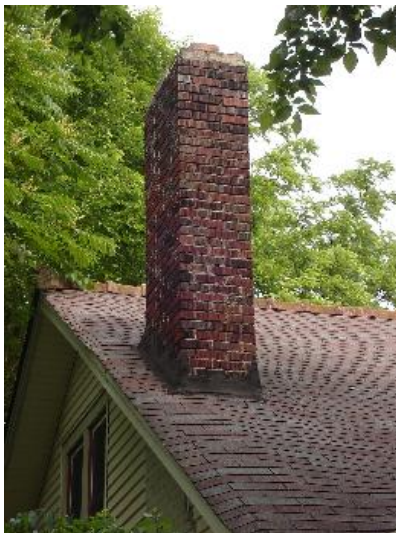
Chimney brick requires pointing; counter flashing/flashings not visible.

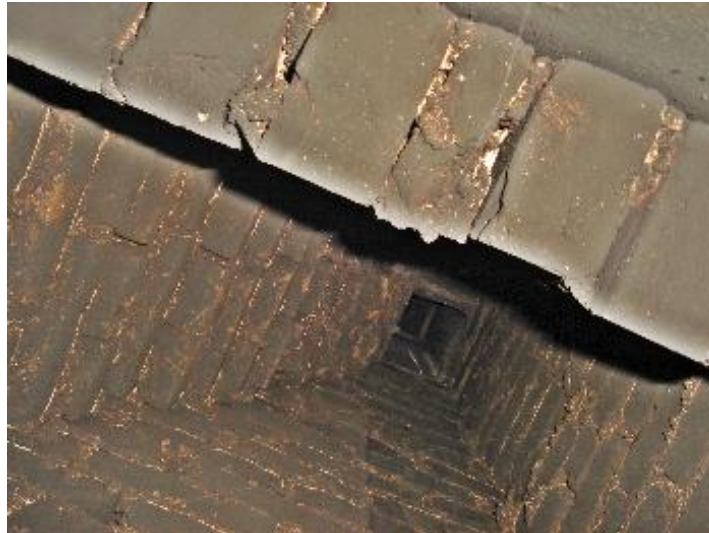
No flue damper in the fireplace. Efficiency concern.

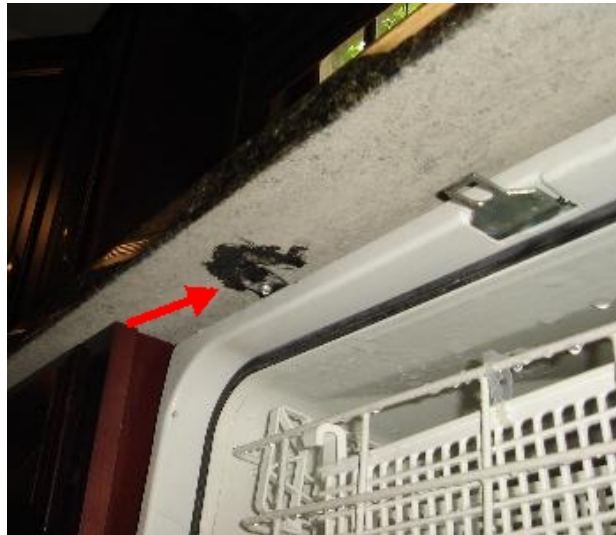
Dishwasher not secured to the countertop. Appliance falls outwards with weight on the door. Personal injury concern.

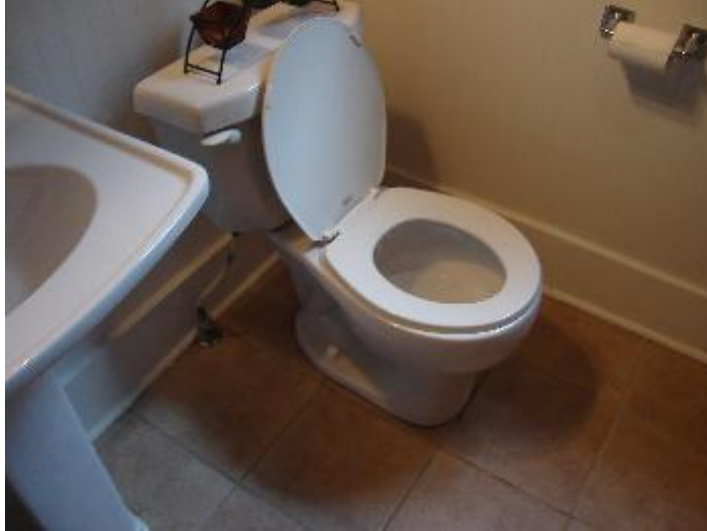
First floor toilet extremely loose at the floor. Remove and examined subflooring and replace wax seal. This toilet did not properly flush. Waste drain restriction or toilet restriction present.

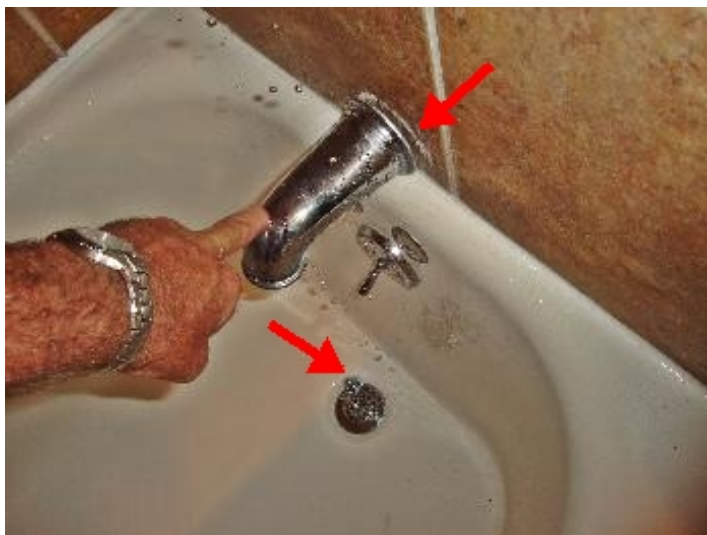
First floor bathtub filled stall pulls from the wall. Moisture intrusion into the wall. Shower valve diverter knob fell off.

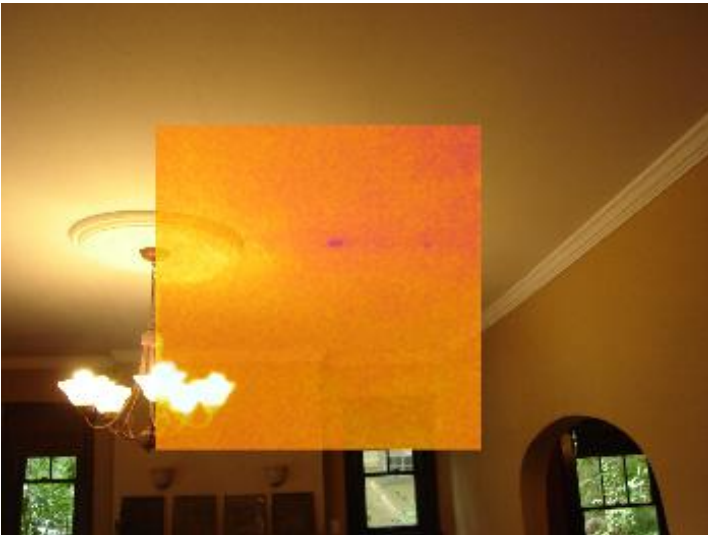
Moisture leakage in the living room ceiling from a leaking HVAC unit above.

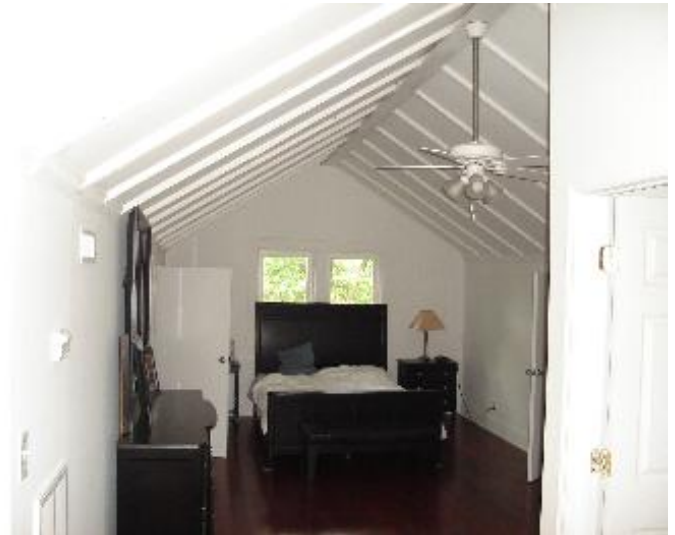
Structural design of the second-floor creates an increase cooling load on HVAC equipment. Construction design must be taken into account when appropriately sizing the equipment. All walls, and ceilings are against unconditioned spaces. There is no attic space above to adequately ventilate the heat above the ceiling.

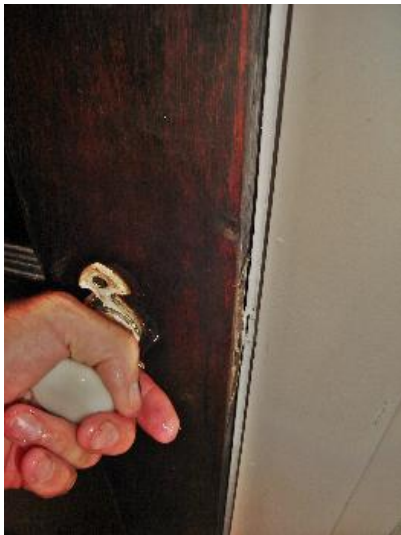
First floor bathroom entry door does not close, latch, or secure. Privacy is expected at bathroom locations.

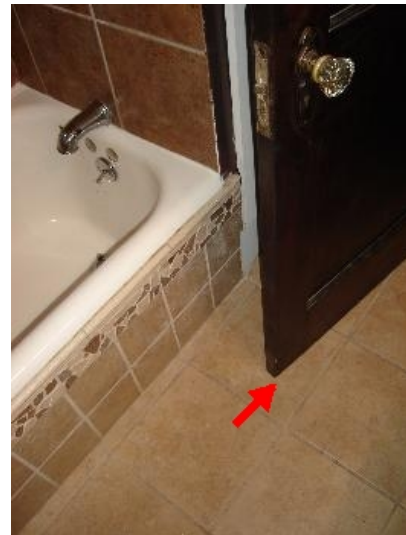
First floor bathroom entry door strikes the tile floor when open. May potentially damage the door.

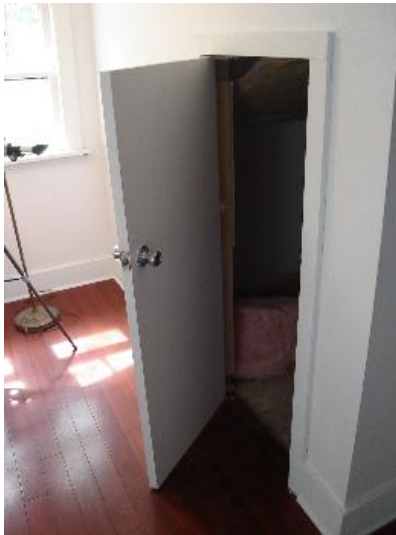
The knee wall access door to HVAC equipment is hollow core and not insulated. Excessive heat build up in the attic area will increase the cooling load from heat transfer through the uninsulated door.

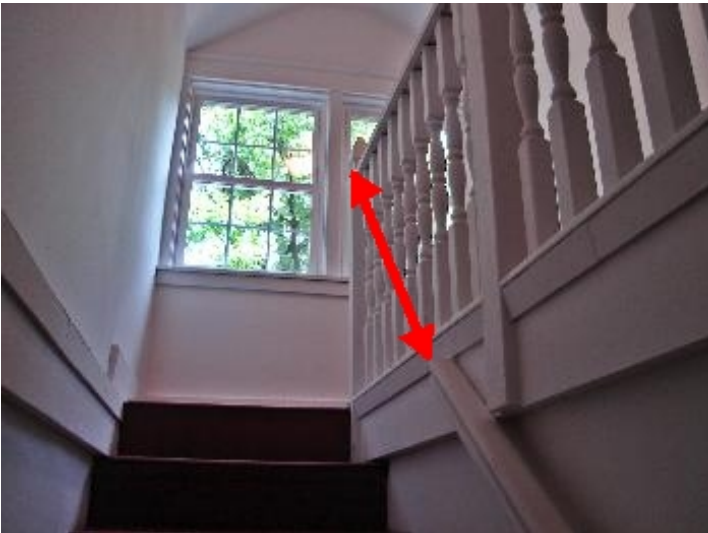
No handrail at the top risers of the second-floor stair system.

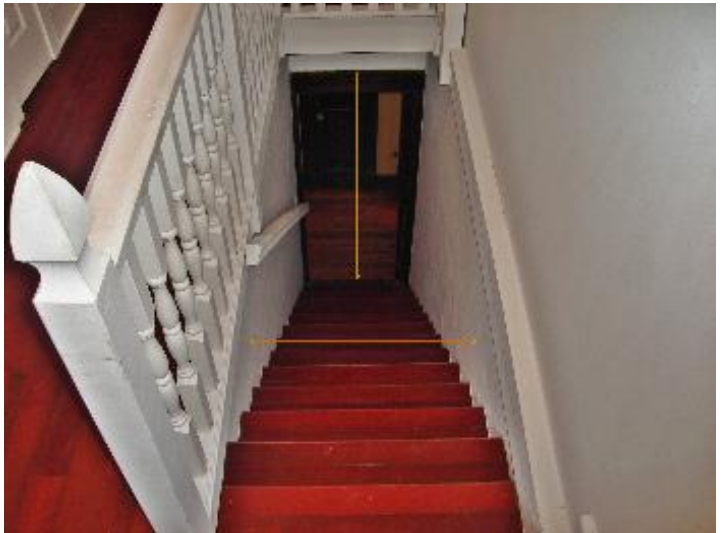
Stair system is less than 3 feet wide. Staircase header less than 6'8" high.

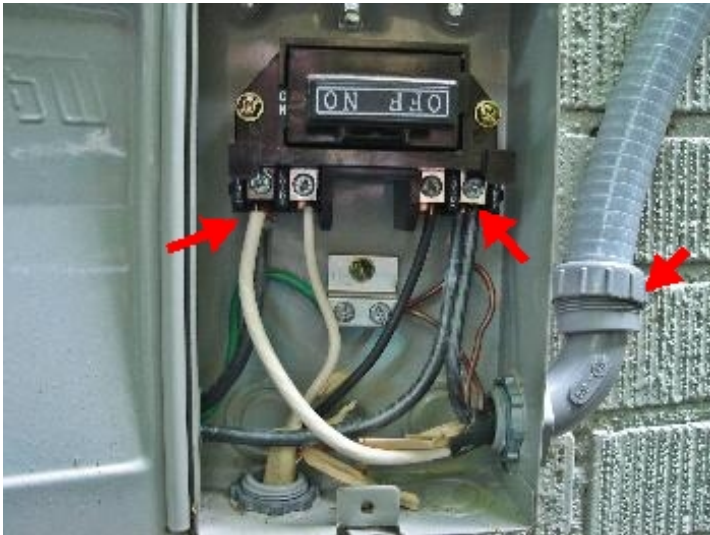
Double tapped electrical supply at the new outdoor HVAC unit. Liquid tight connector not properly installed; cross threaded.

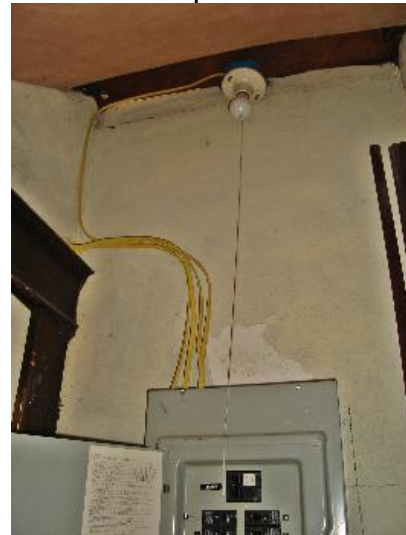
Exposed Romex wiring outside of the finished wall. Improper lighting fixture. Inadequate clearance between in incandescent light fixture any finished wall and ceiling. Light bulb fixtures not protected.

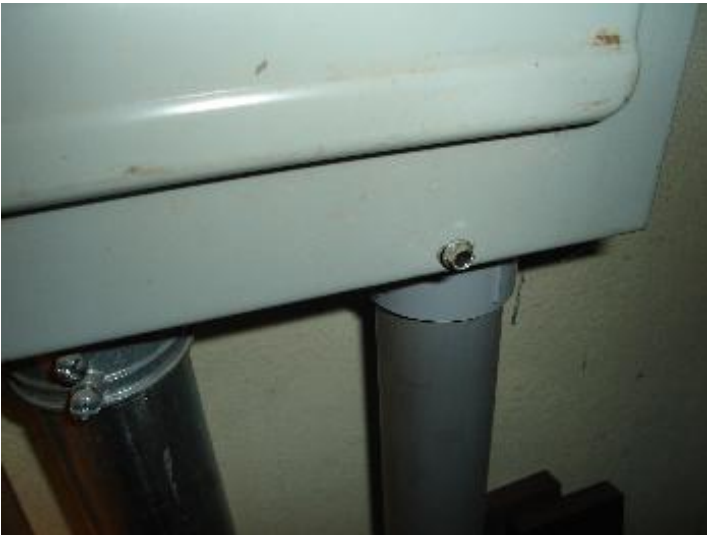
Sheet metal screws utilized on electric subpanel cover. Main electric subpanel was not inspected due to this hazardous condition.

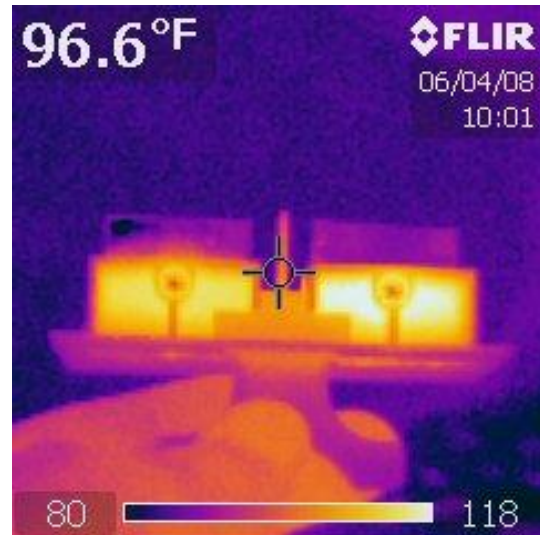
Disconnect plug at the first floor HVAC disconnect shows uneven heating patterns indicating an imbalanced load/electrical supply deficiency/defective disconnect.

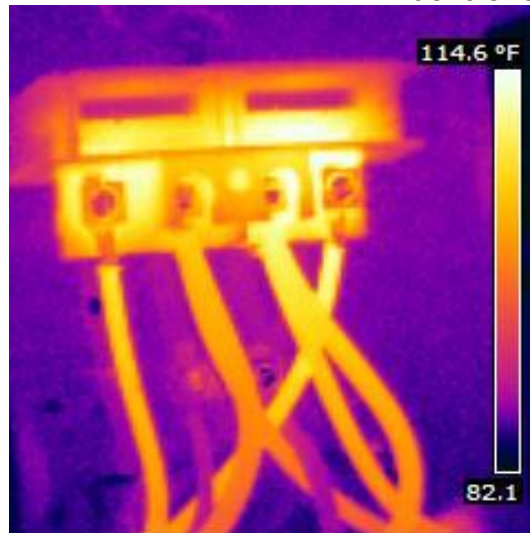
Overheated condition of the first floor HVAC disconnect. Disconnect components are overheated as well as double tapped electrical wiring. There is no overload protection for this wiring size observable. Double tapping creates an overloaded condition which is apparent in this case.

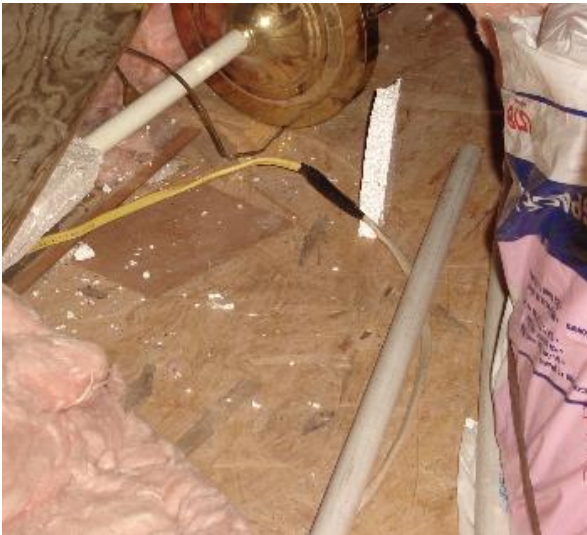
Visible spliced wire outside of a junction box in the attic.

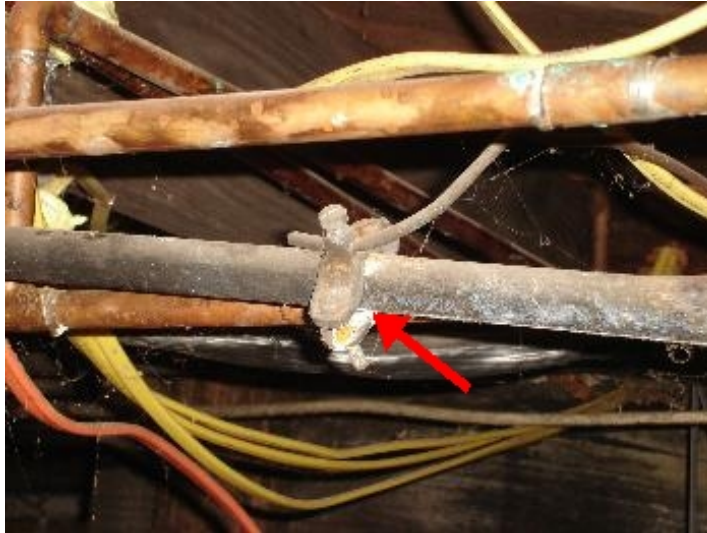
Electrical ground connections at old Hellenized water pipe which has been disconnected and no longer provides adequate grounding. This grounding clamp should be moved to an active water supply line.

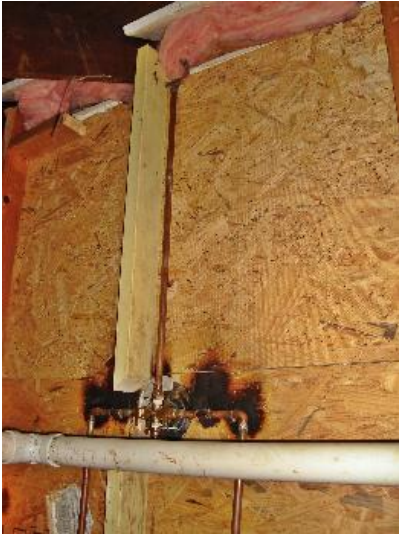
Cut wall stud not properly drilled or supported. Shower valve not properly secured to the framing to prevent movement/ potential leakage. Uninsulated wall against the shower. Water piping in an unconditioned spaces; potential freeze issue. Excessive scorching of the adjacent wall materials from an adequate soldering procedures.

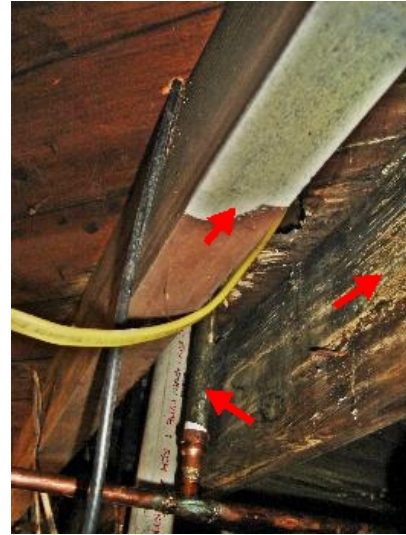
Galvanized pipe still installed on the upgrade copper piping in the house. Staining of the water at the first floor vanity sink was observed above this location.

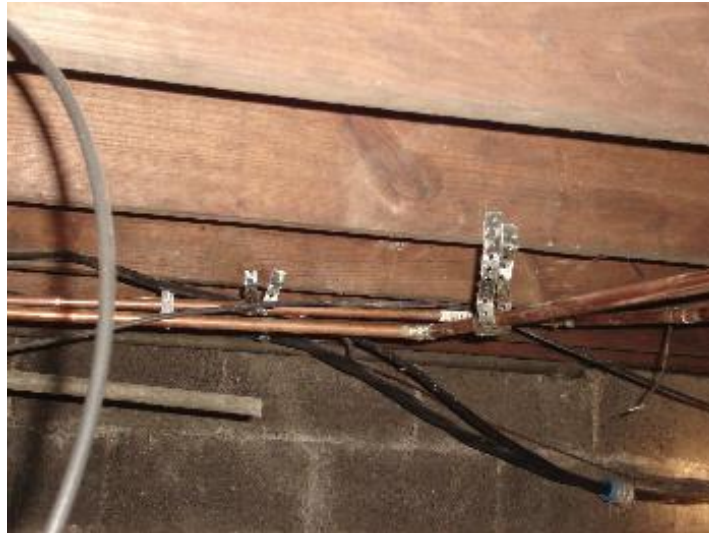
Improperly supported plumbing lines. Improper fasteners and inadequate support schedule.

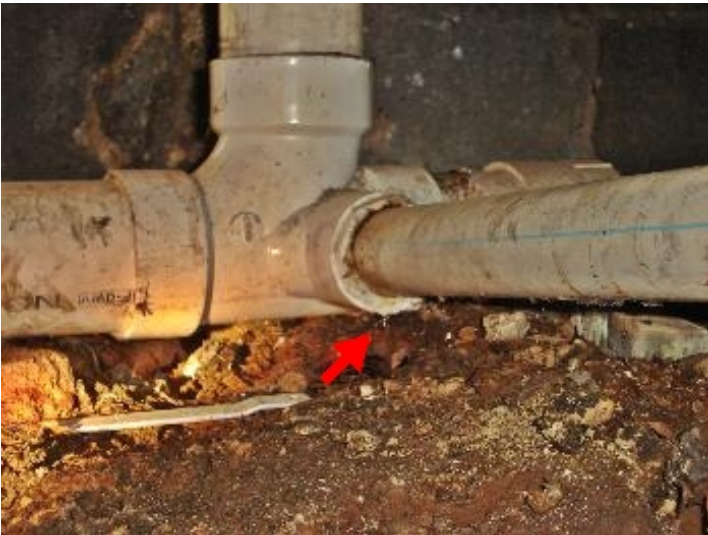
Waste drain leakage observed

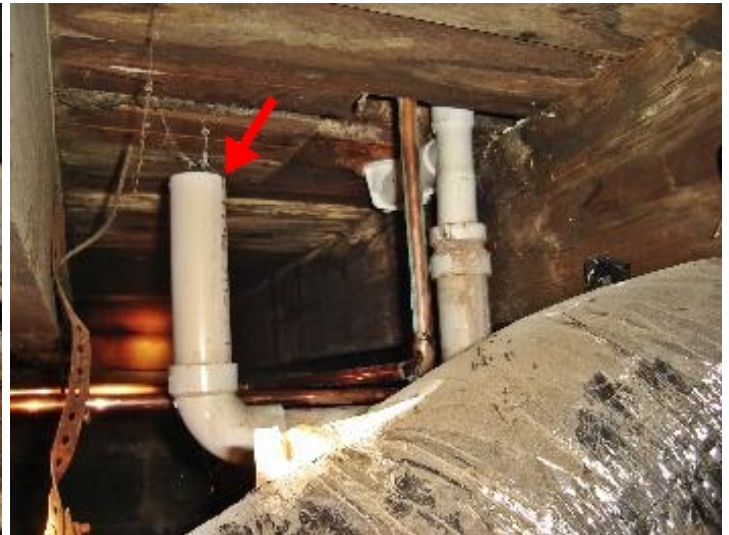
Waste drain is open to the basement atmosphere. No pipe cap installed.

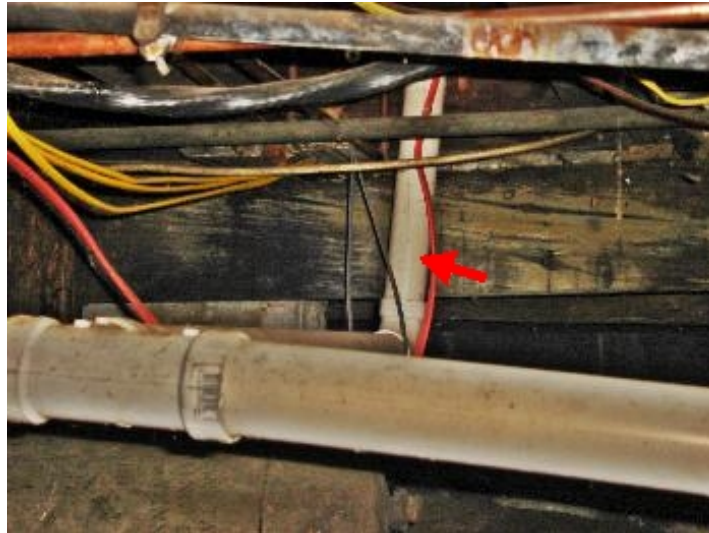
There was no trap in a washing machine drain line observed. Potential infiltration of sewerage gases into living space of the house is possible.

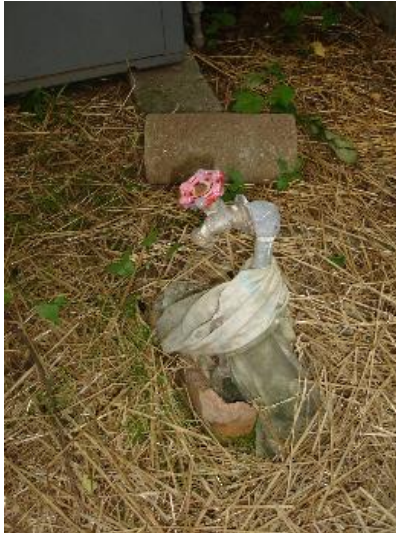
Exterior water supply; no water flow.

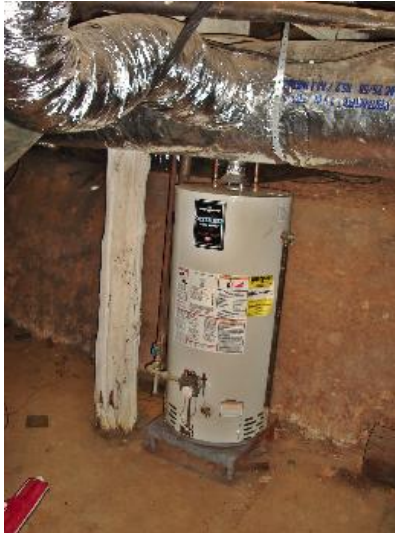
Gas-fired water heater is not 18 inches above the floor. Pressure temperature diverter pipe is not installed within 6 inches of the floor.

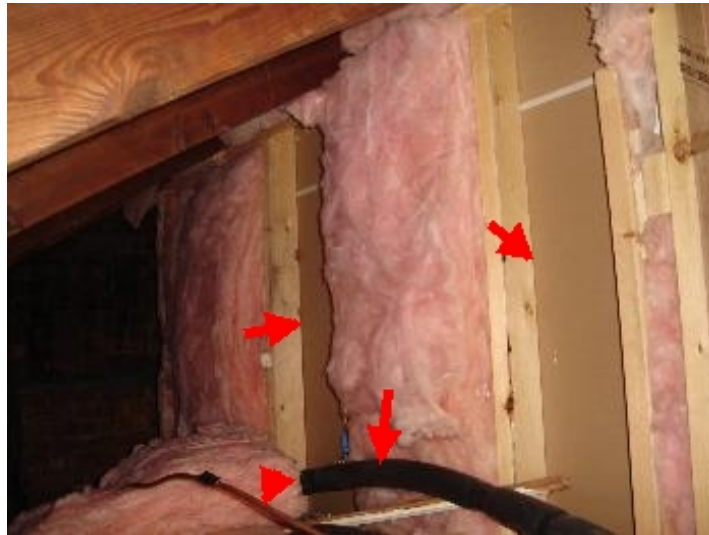
Missing insulation in the bedroom/attic wall. Unsupported refrigeration lines.

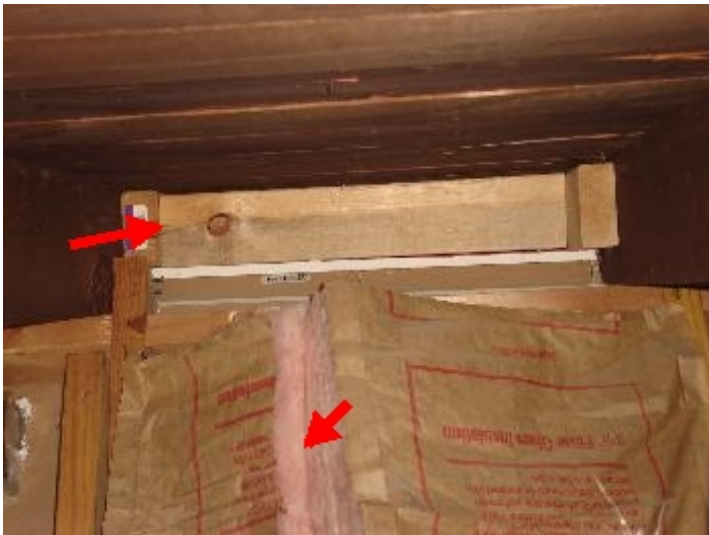
Roof Rafter ventilation is sealed above the knee wall. Baffles are required for adequate ventilation of the roofing system. This also increases heat gain on the cooling system.

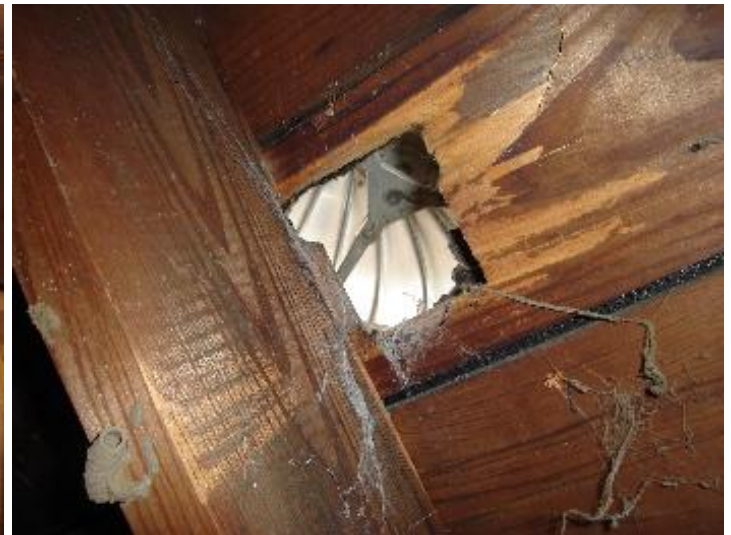
Inadequate opening below roof ventilator. Substantially reduces attic ventilation capacity which is insufficient to start with.

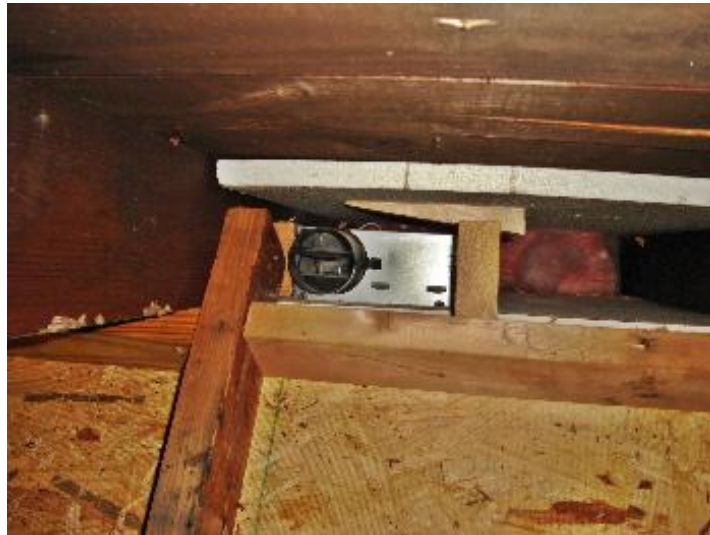
Bathroom ventilator discharges directly into the attic. High moisture content of this air will condense on the roof and cool weather in damage the roofing system and framing members, potentially causing mold damage to the structure.

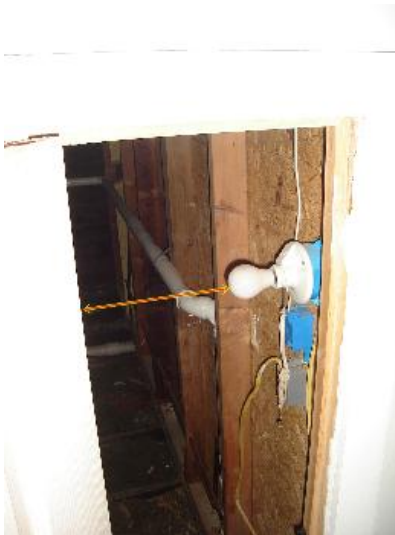
Inadequate clearance to the attic access (behind the second bathroom wall). Incandescent light bulb fixtures installed; not appropriate for this application. Inadequate clearance of incandescent light fixture. Inadequate support of Romex wiring at receptacle boxes as required.

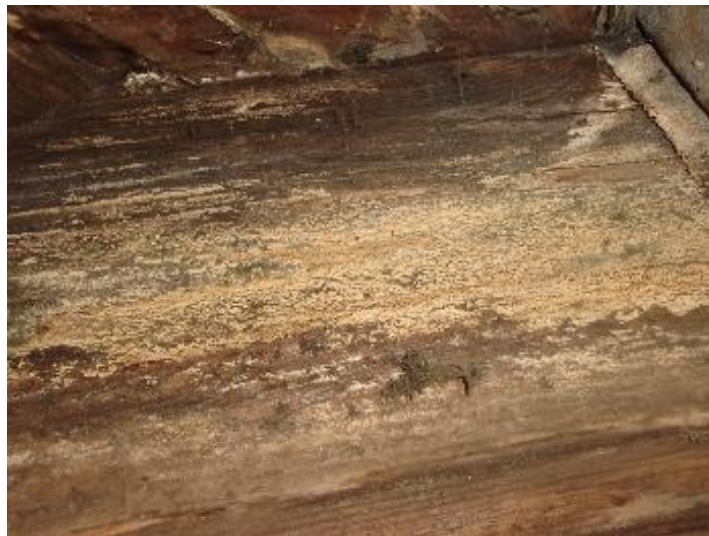
Organic substance on subfloor framing. This organism may damage structural components. Excessive moisture within the space associated with this condition. Increase validation is recommended.

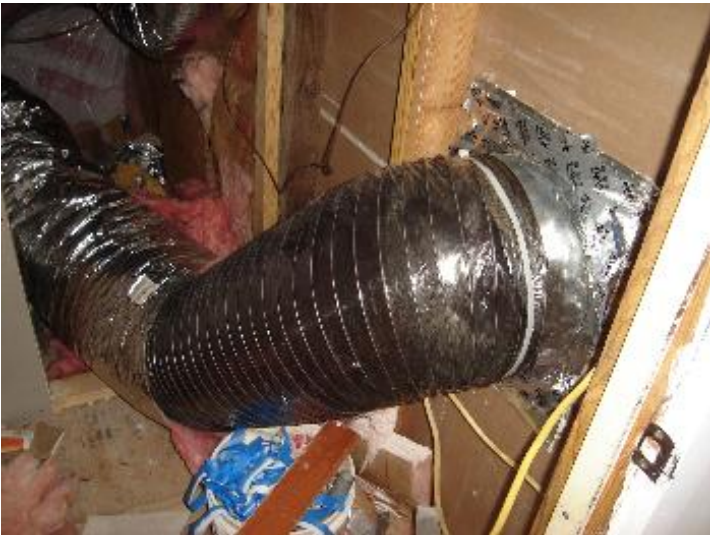
Return air duct is not insulated. Return air grill is not the appropriate size. There is no return air plenum at the filter grill as required for proper operation. Air duct causes limited access (confined space) to the HVAC equipment and attic space. Romex wiring not properly secured as required. Uninsulated sheet rock wall.

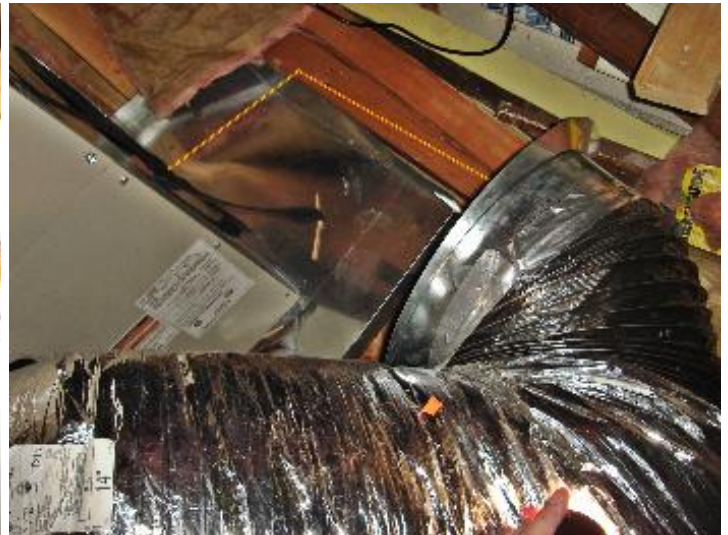
Return air duct is not secured to the unit. No return air plenum box constructed/attached to the unit.

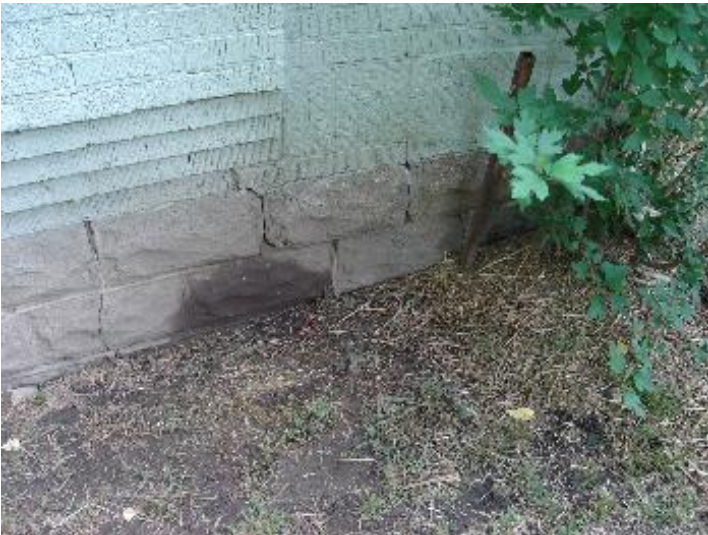
Condensate water on foundation from drain above. Excessive moisture intrusion into the crawlspace. Potential structural damage from expansive soils and hydraulic pressure.

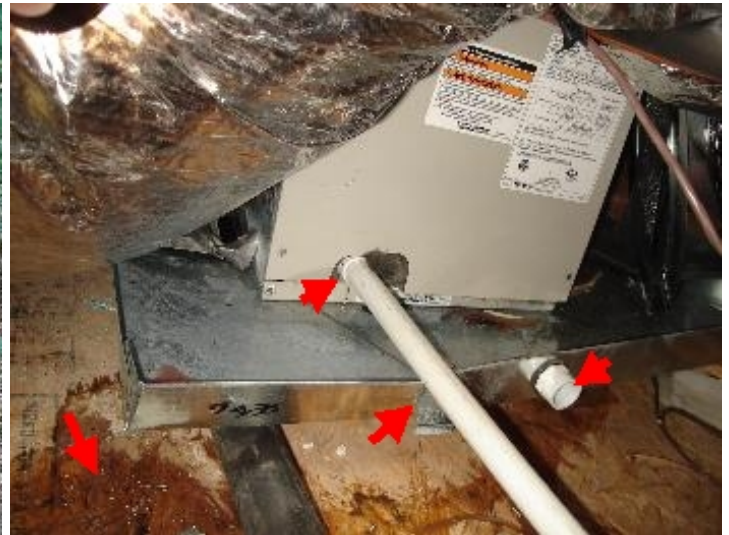
HVAC unit not properly level. Condensate leakage at drain connection. Condensate leakage from flooded interior unit. Auxiliary drain pan cut to facilitate drain. The unit should be raised above this level. Condensate leak out the pan. Condensate drain pan is not level. Condensate drain pan overflow piping not installed. Condensate drain does not have a trap installed as required (this will cause the coil pan to overflow during operation; it is also an efficiency concern as unconditioned outdoor air will be drawn in through the pipe.). Obvious water leakage on the attic flooring (resulting in ceiling damage below). No drain pan safety switch installed to shut down the unit in the event of an overflowing pan due to a condensate leak.

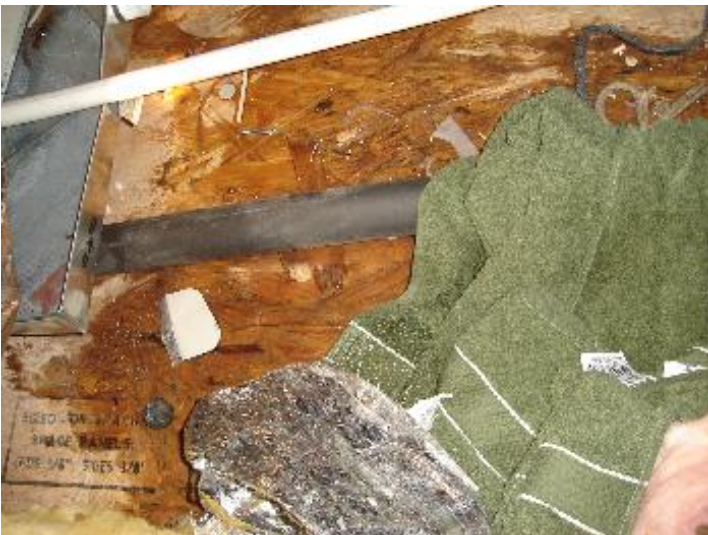
Water damage on attic flooring. A towel was present (apparently the leak was known earlier).

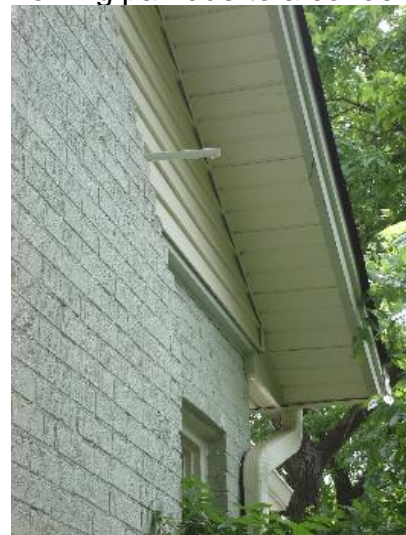
Improper condensate drain line termination from HVAC equipment.

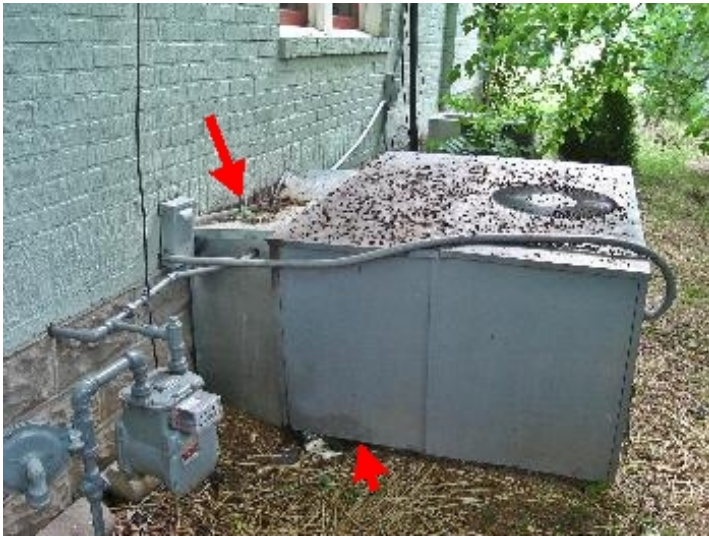
HVAC unit out of level. Condensate flooding the interior of the unit. Indication of freezing evaporator coil. Condensate leaking from service panel. Crushed air duct good between unit and building; source of water intrusion into the crawlspace.

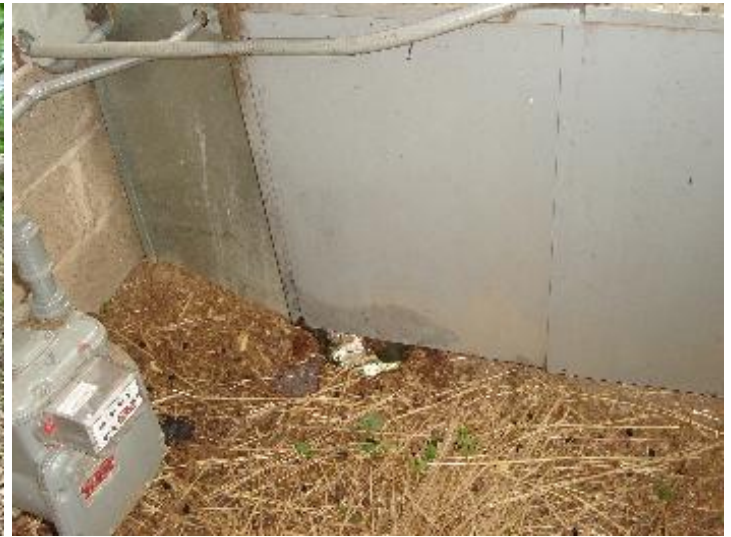
Leaking condensate/drain pan/frozen coil.

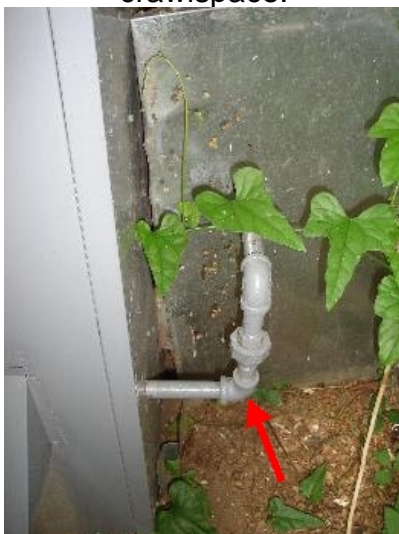
No drip leg on gas piping.

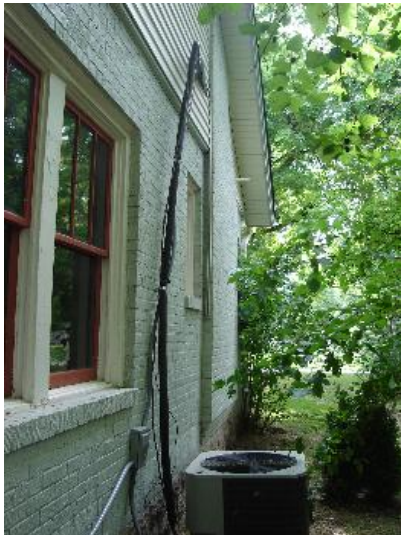
Improperly supported refrigeration line sets. Improper termination of the condensate drain line overhead.

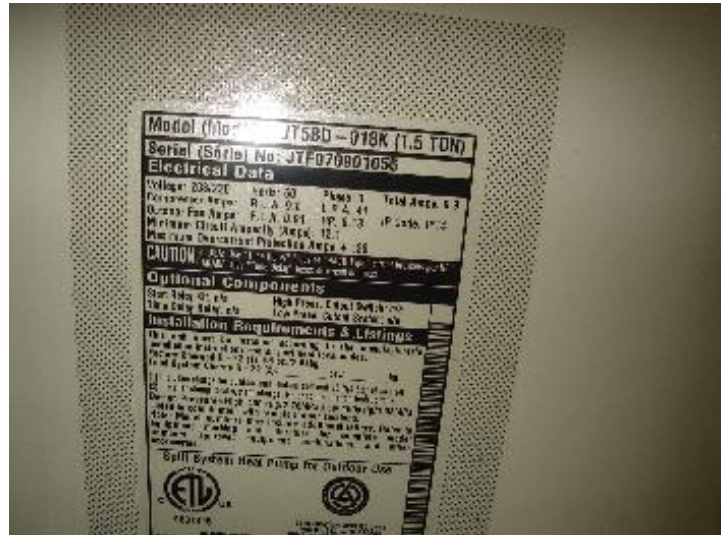
HVAC unit is 1.5 tons for the second floor. There is no indication of cooling load calculation compliance. System may or may not be inadequate for required comfort levels on the second floor.
