David A. Andersen & Associates

Home Inspection Report

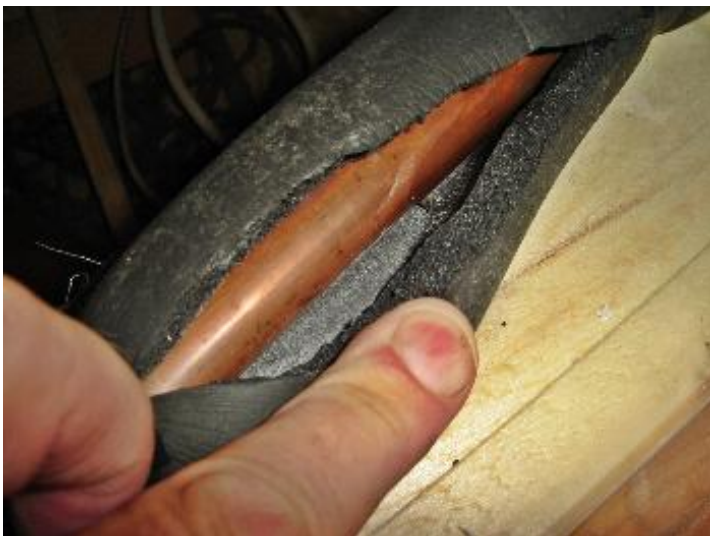
Condensate water inside a cut insulated refrigerant line. All cuts and butt joints connections on refrigerant insulation must be sealed with contact cement appropriate for this application to prevent air contact with the piping. Water will eventually leak out and damage the ceiling below.

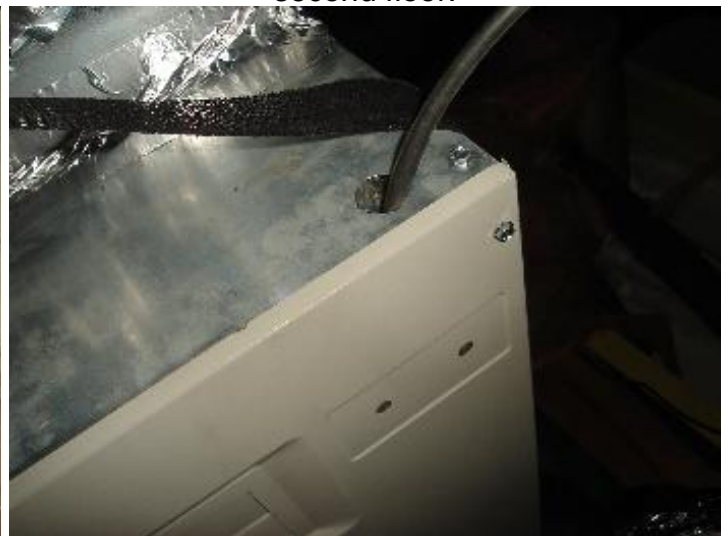
Improper wiring connections at equipment case penetration. Vibration may result in a high voltage ground fault. Interior components of this equipment were not inspected due to safety hazards to the inspector. Wiring may not be appropriately sized. Auxiliary heating banks may not be installed/appropriately sized/have adequate wire capacity/have adequate breakers/fuse protection. Investigate further. The equipment electrical disconnect is attached to the roof decking. This does not conform to industry standards. This panel was not further inspected.

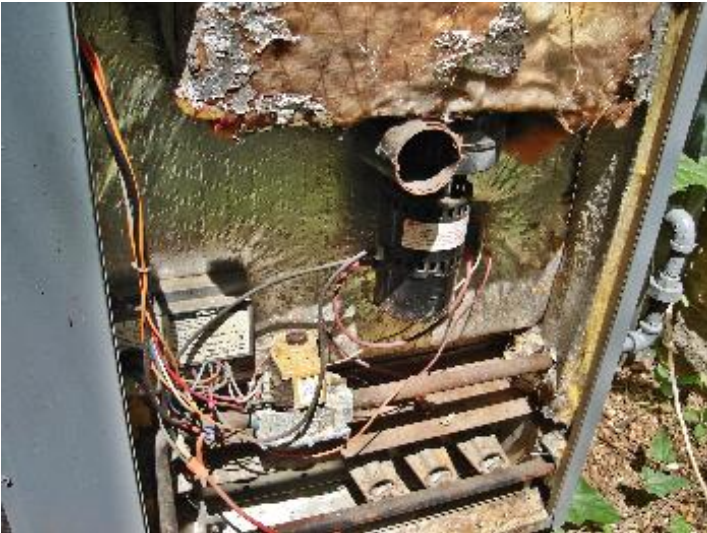
First floor gas compartment condition.

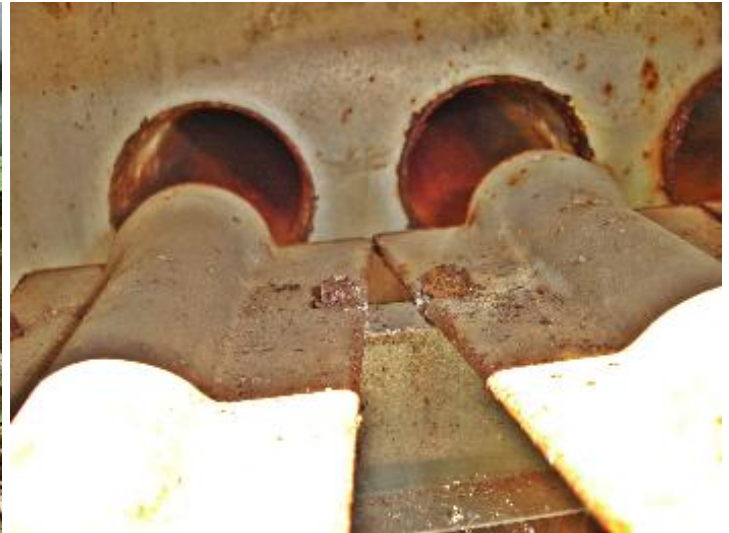
Gas burner/heat exchanger condition. Excessive rusting inside of the exchanger requires maintenance /further inspection by dismantling the unit.

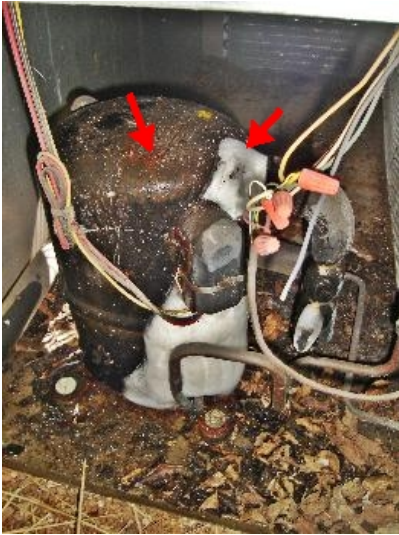
Frozen first floor air-conditioning compressor. Restricted airflow at coil. Low refrigeration pressures. Equipment requires dismantling/inspection and servicing. Rusted compressor head indicates an ongoing past occurrence of this condition. Evaporator coil is likely restricted.

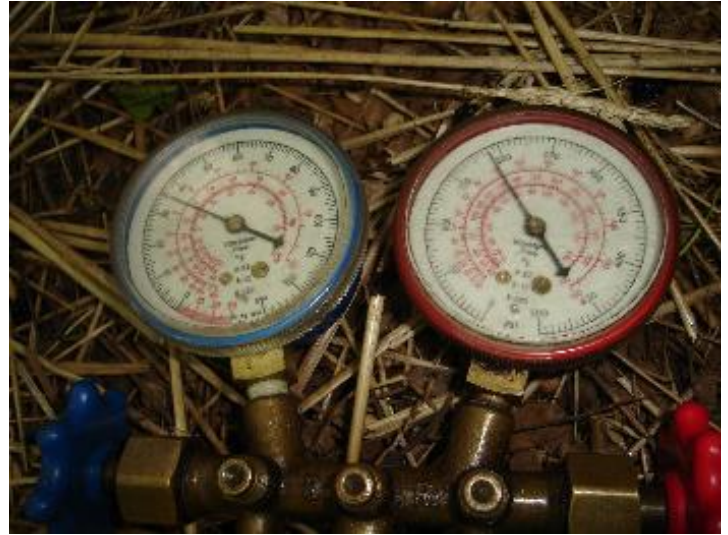
Low refrigeration pressures. First floor unit.
